Debris/Ice/TPS Assessment and Integrated Photographic Analysis of Shuttle mission STS-102

Technical Memorandum – 2001 – 210257

May 2001

**DEBRIS/ICE/TPS ASSESSMENT
AND
INTEGRATED PHOTOGRAPHIC ANALYSIS
OF
SHUTTLE MISSION STS-102**

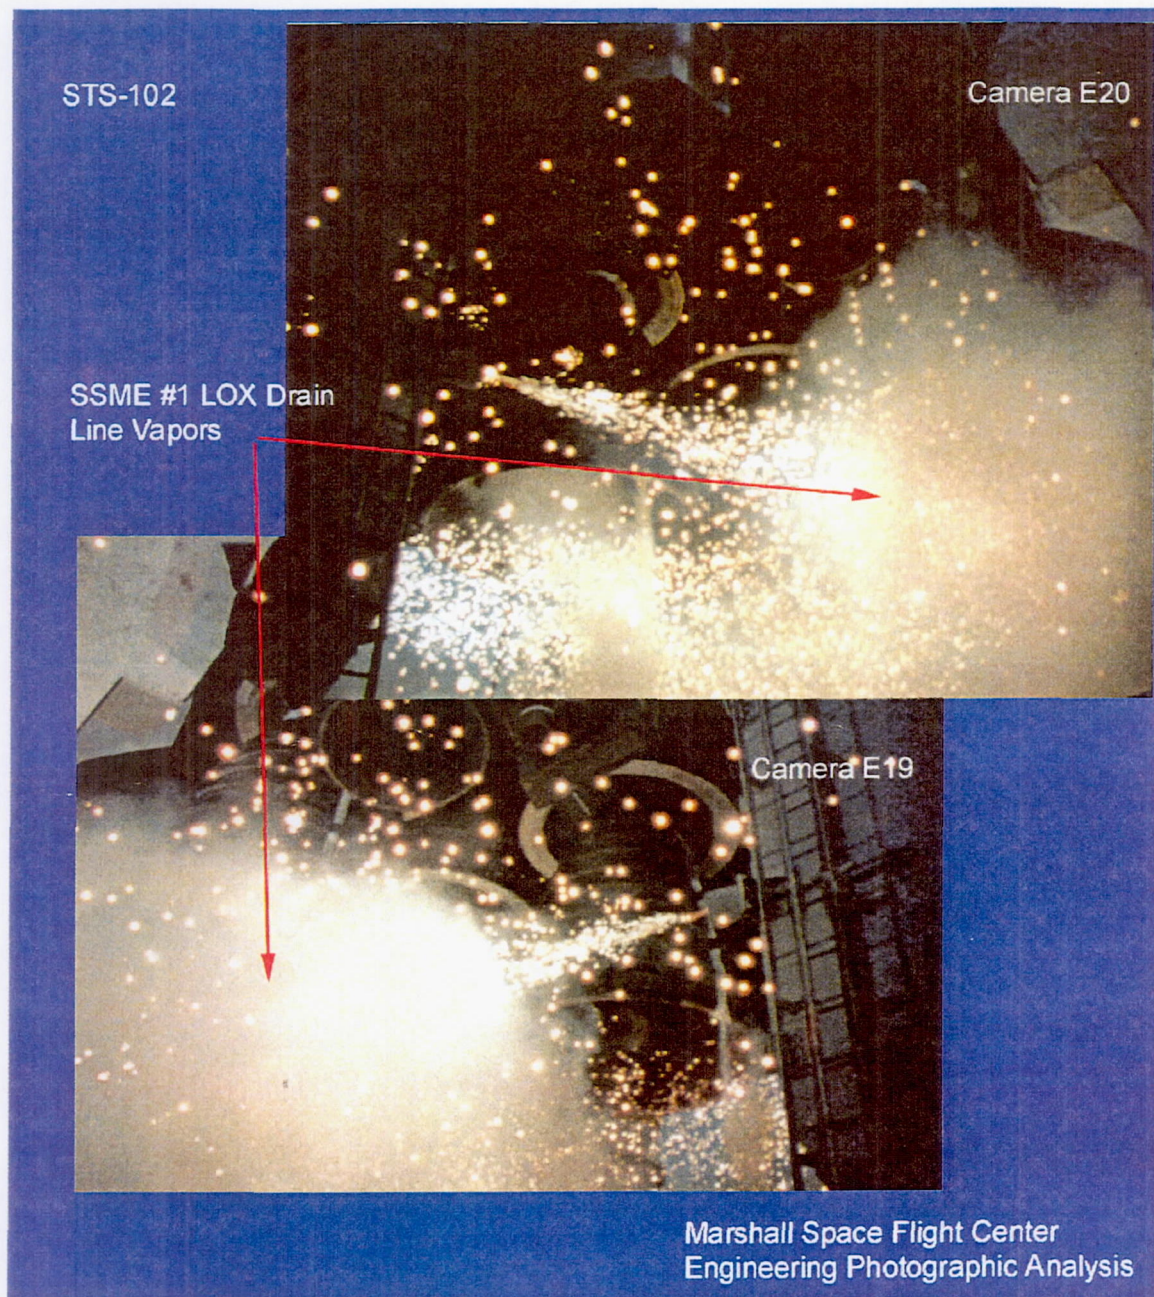
Figure 11. SSME#1 LOX Vent Cloud

An unusual cloud, presumably LOX vapor originating from an SSME#1 LOX vent drain line, was observed on this mission. Possibly a shift in the winds from the SSME flame exhaust hole toward SSME#1 caused this accumulation of vapors.

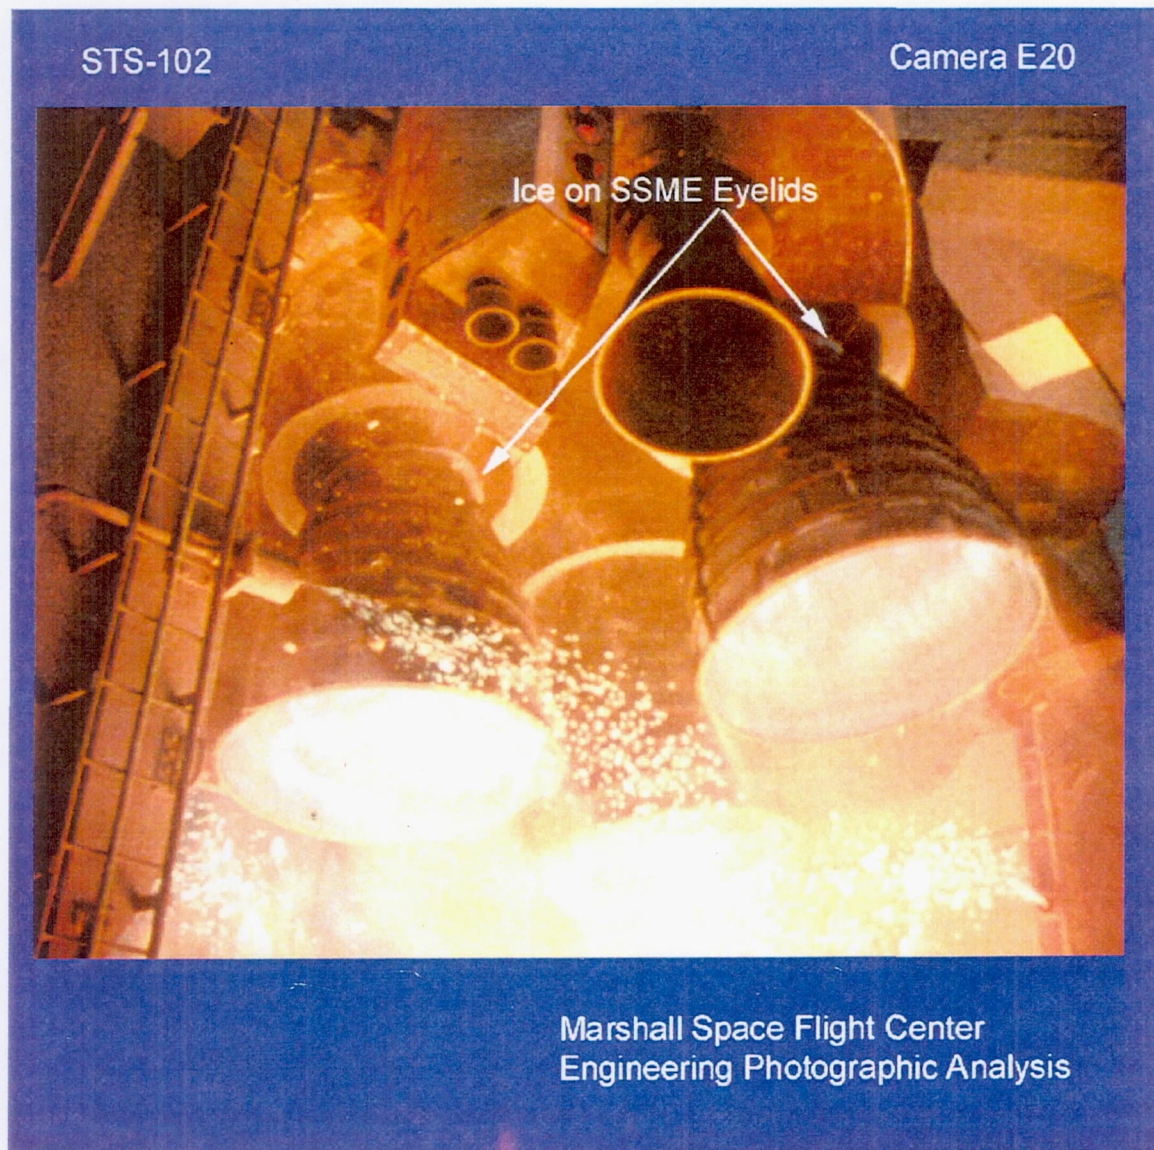
Figure 12. Ice on SSME Eyelids

Ice or frost was observed on both SSME#2 and SSME#1 eyelids. It is uncommon to see the ice or frost on SSME#1 eyelid.

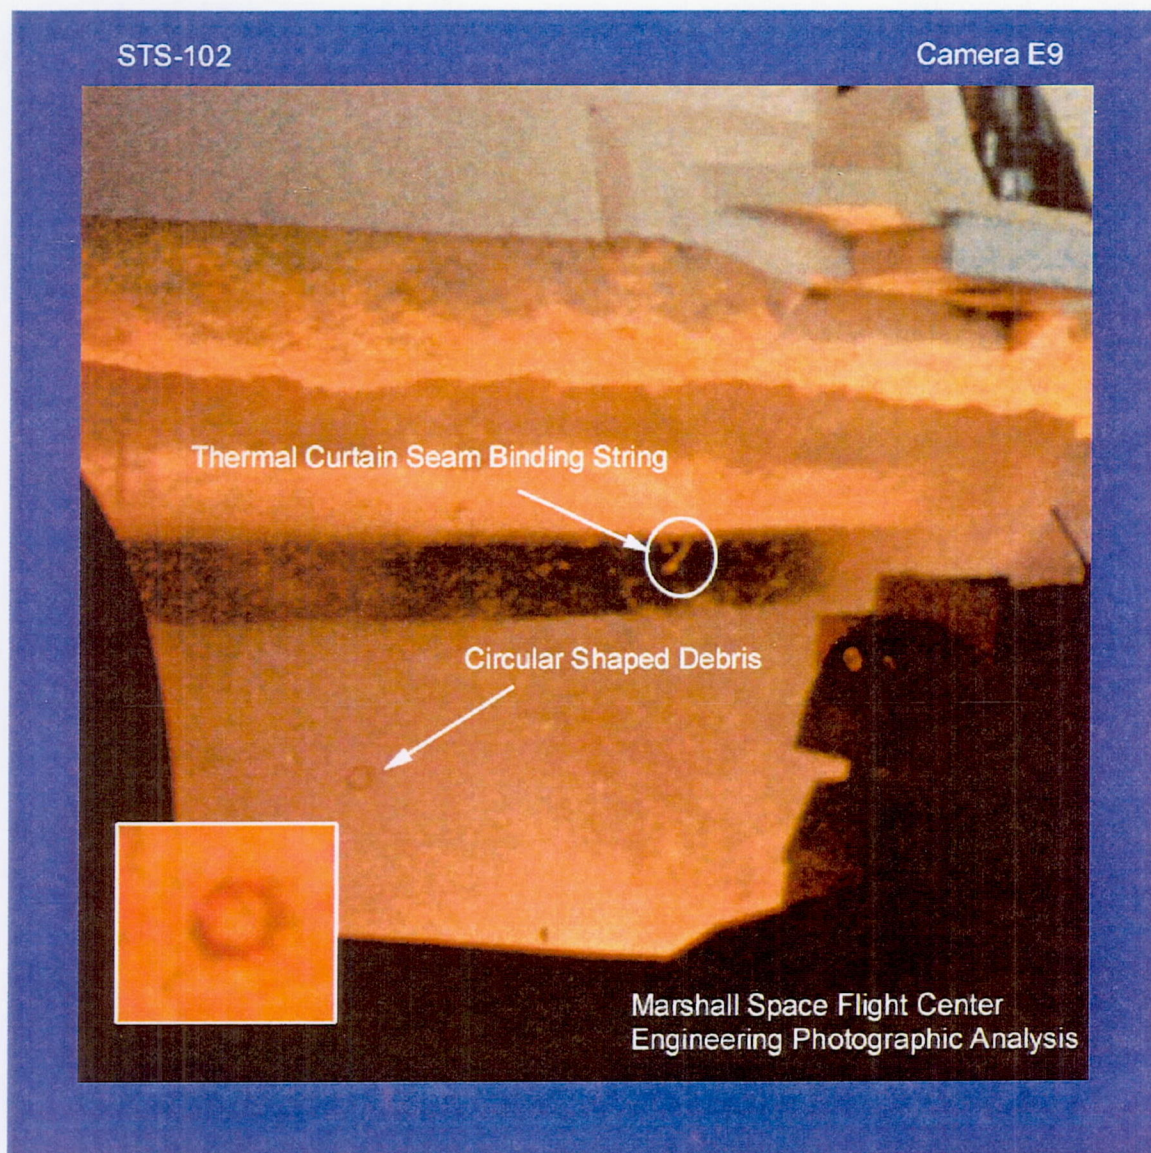
Figure 13. Circular Shaped Debris Object near Holddown Post M1

A circular shaped debris object was noted just after liftoff. Also, ends of threads used to bind Thermal Curtain Seams were noted.

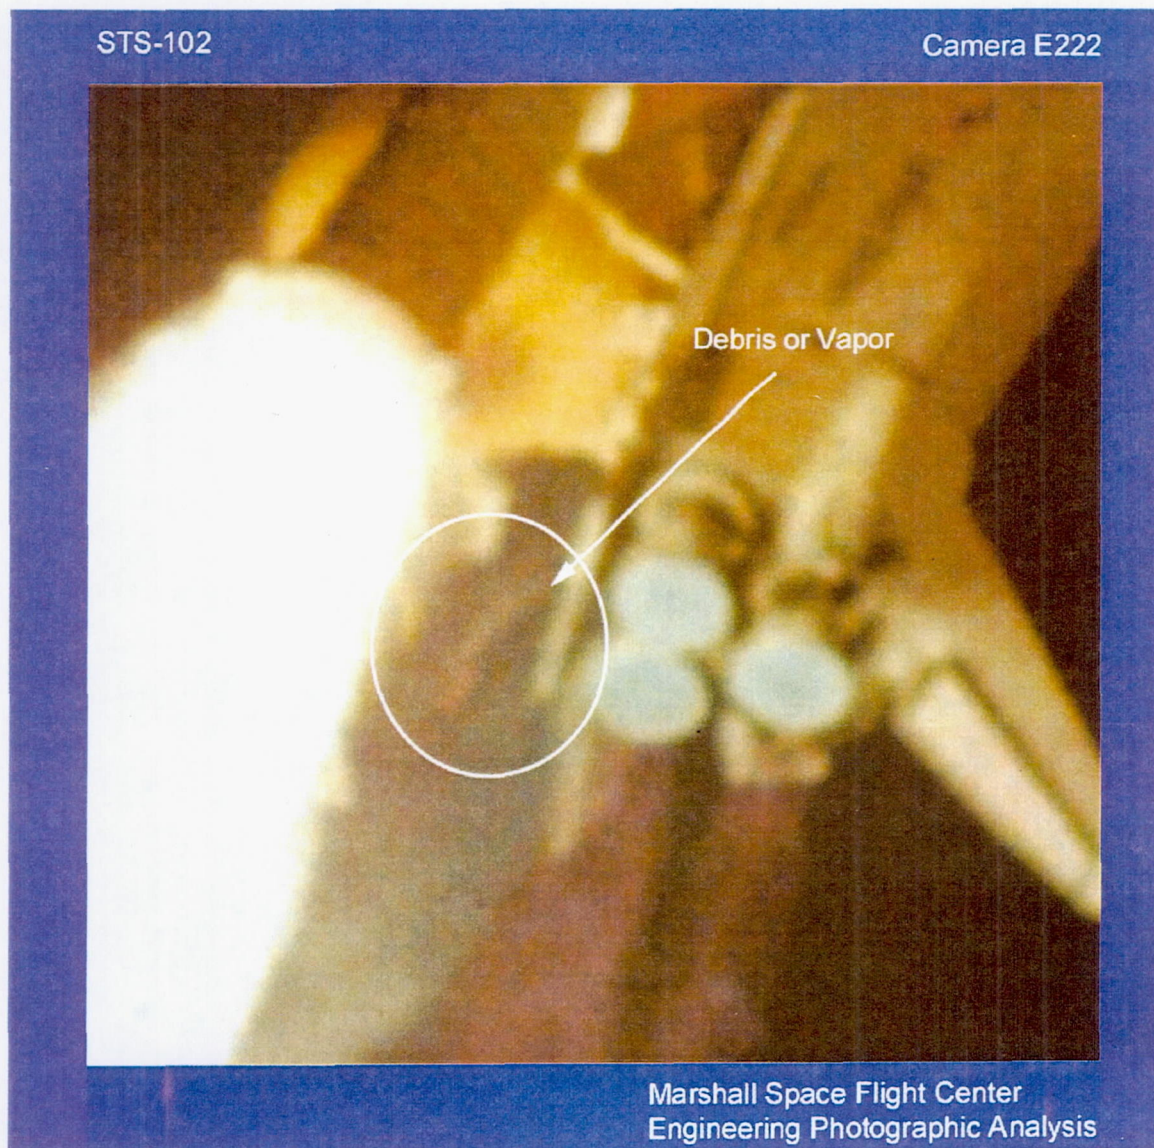
Figure 14. Debris or Vapor Streak

A possible debris or vapor streak was observed apparently between the Orbiter Body Flap and the SRBs.

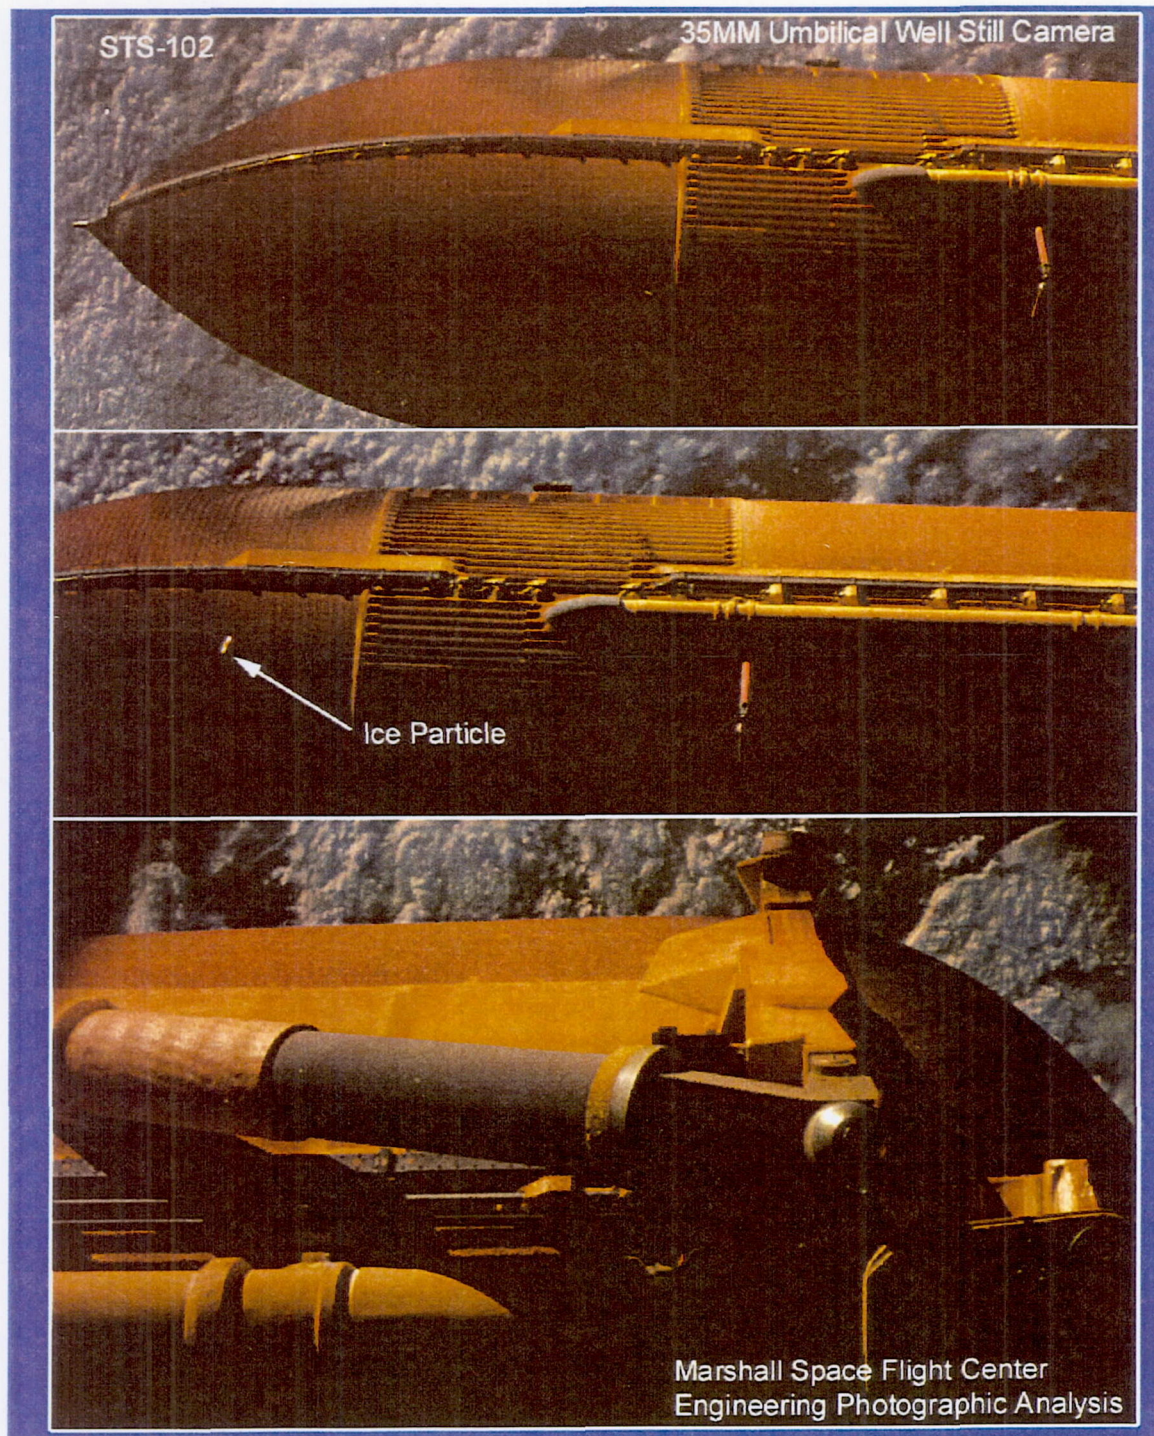
Figure 15. External Tank TPS

TPS on External Tank appeared to be in very good condition. Several small ice particles were noted in the field of view between the Orbiter and the ET. Popcorning in the vicinity of the ET aft dome appeared minimal. The protruding EO-3 interface Joint Bolt may be seen in the bottom image of Figure 16.

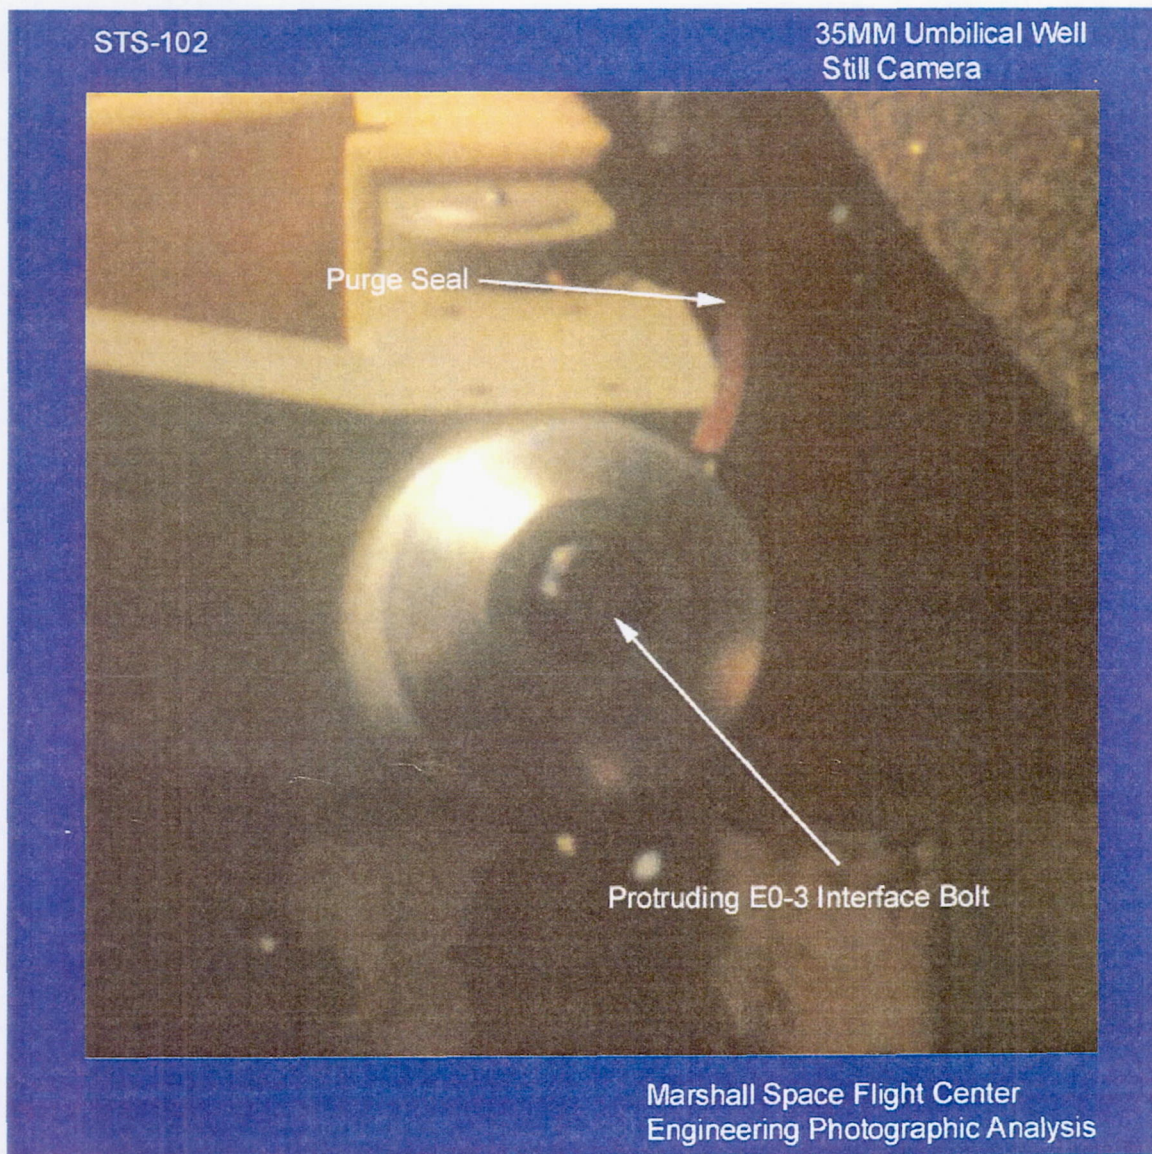
Figure 16. Protruding EO-3 Interface Bolt

The EO-3 Interface Bolt was noted to be protruding from the bore of the EO-3 Interface Ball Joint. Also, the tethered red-colored purge seal was observed near the joint.

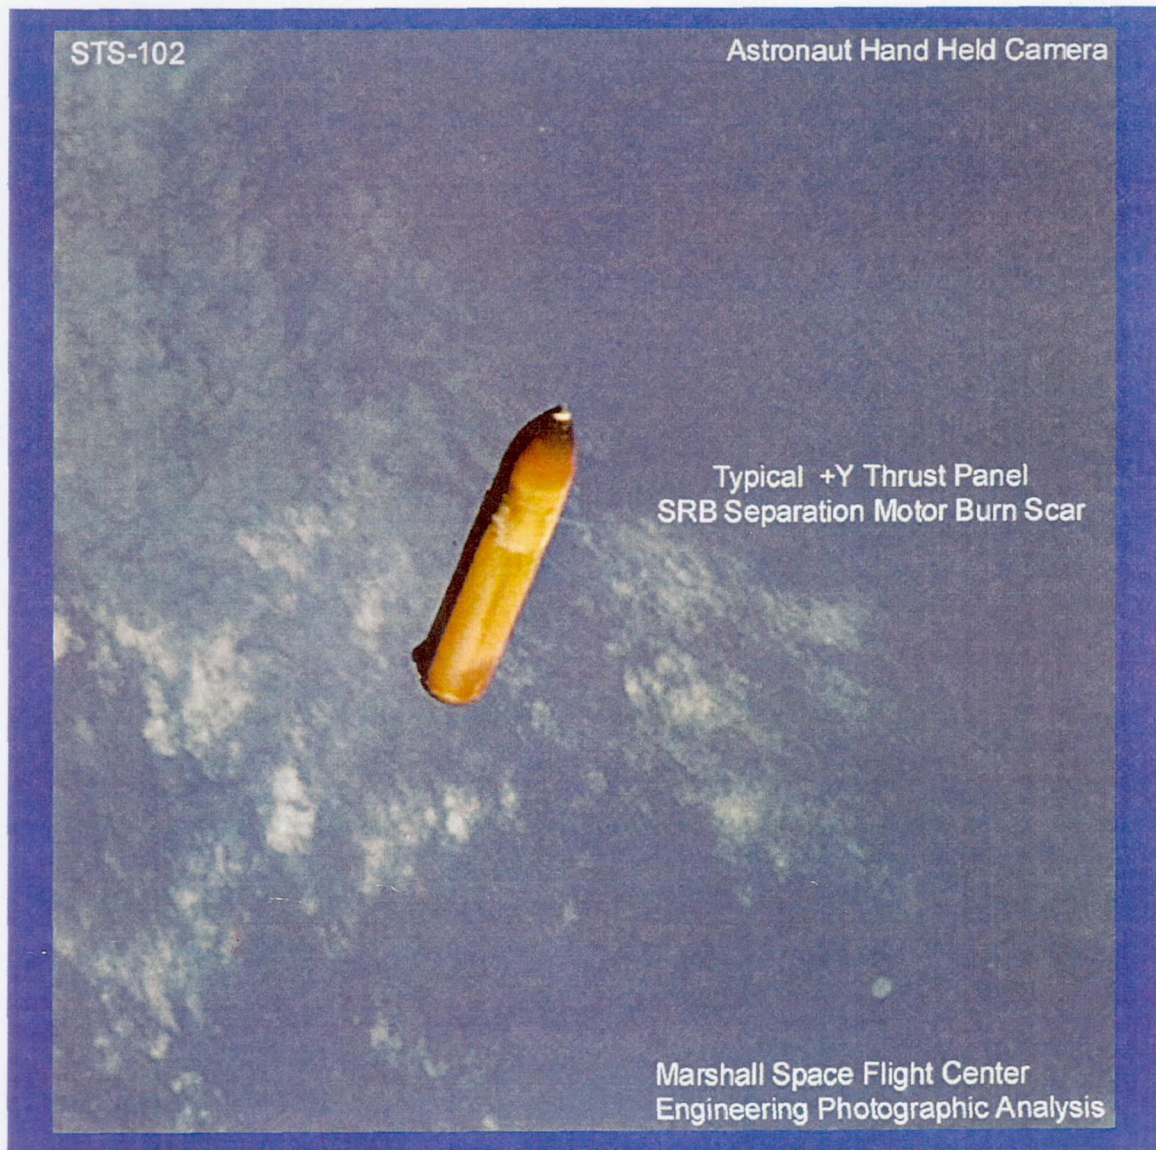
Figure 17. External Tank +Y Thrust Panel

No substantial divoting could be discerned on the ET TPS and no venting from the ET was noted on the handheld video.

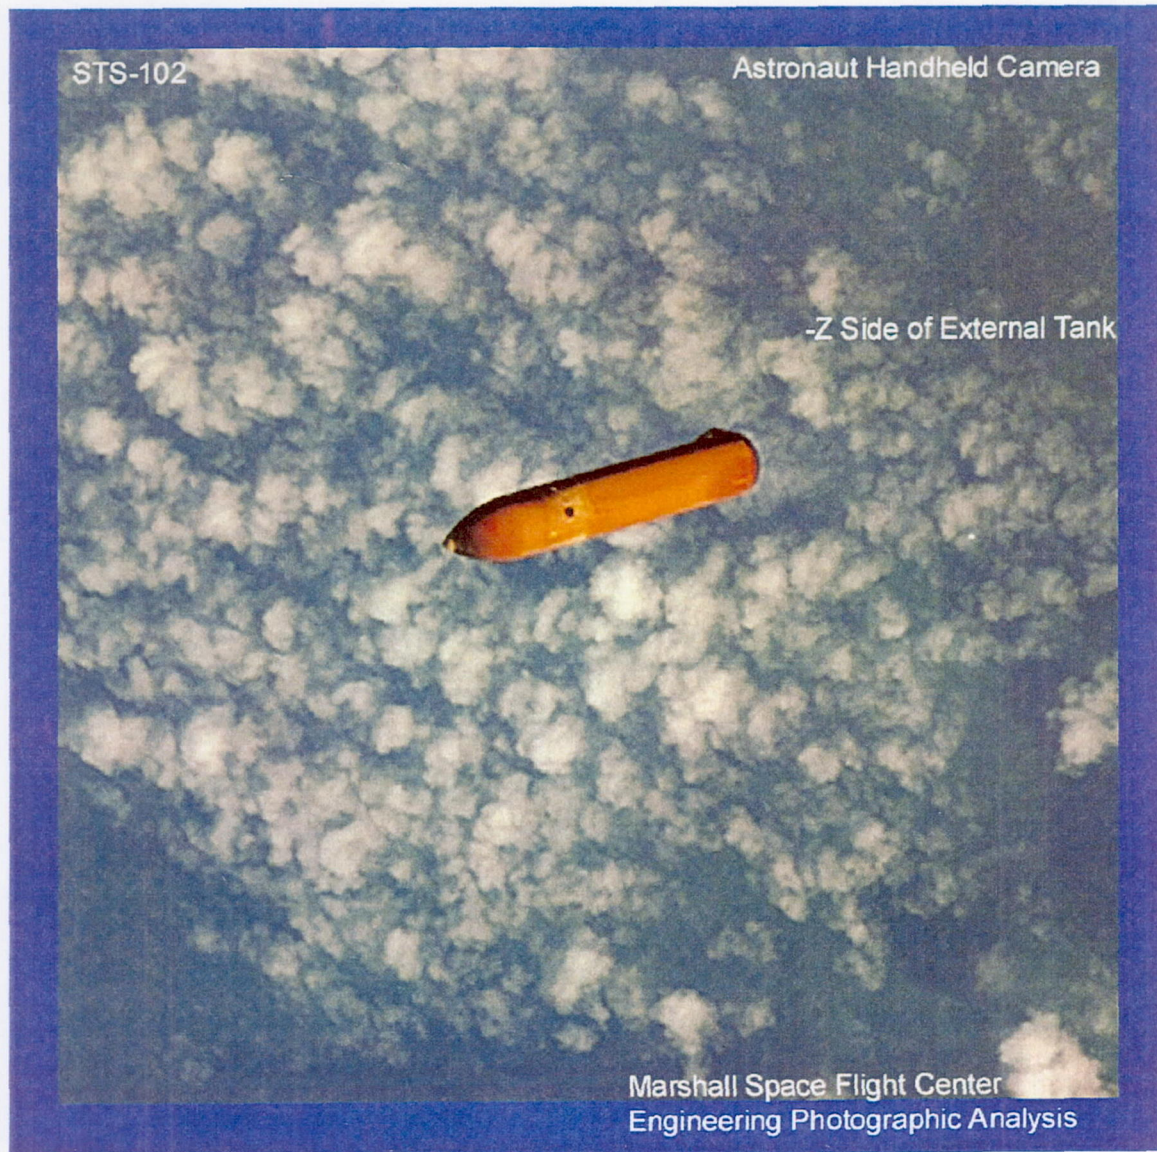
Figure 18. External Tank -Z Side

Typical aeroheating of the nose TPS was observed on the -Z side of the External Tank TPS.
